Historic Structures Report
Renwick Courthouse, Wallace Library, and Old Jail
City of Fredericksburg, Virginia

Created / Last Revised:
19 April 2016/ 15 June 2016

Prepared by:
Bryan Clark Green, Ph.D.
Commonwealth Architects
101 Shockoe Slip, Third Floor
Richmond, Virginia 23219

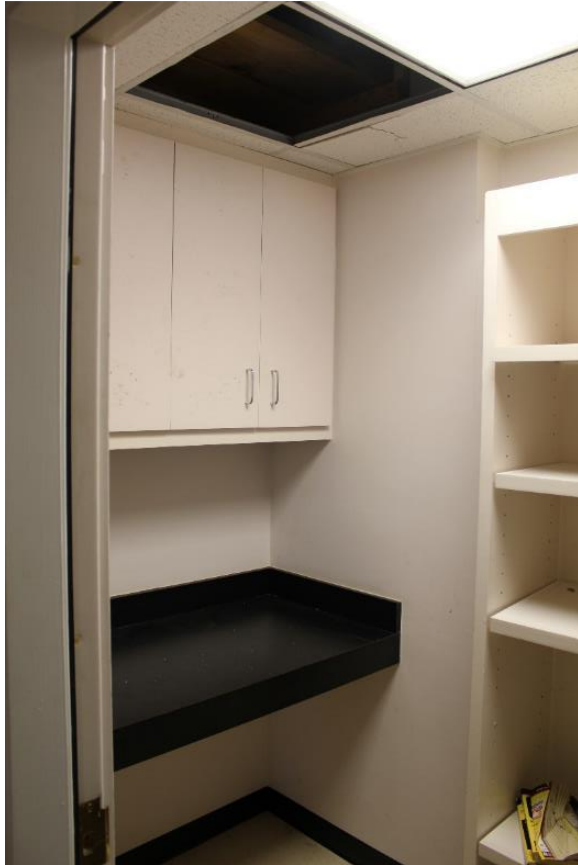
Figure 3.196, Historic Courthouse, Second Floor, Room 226, general view. Note the missing ceiling tile and adjacent cracked tile.

The ceiling is covered in suspended acoustical tile. One of the tiles is missing and an adjacent tile is cracked.

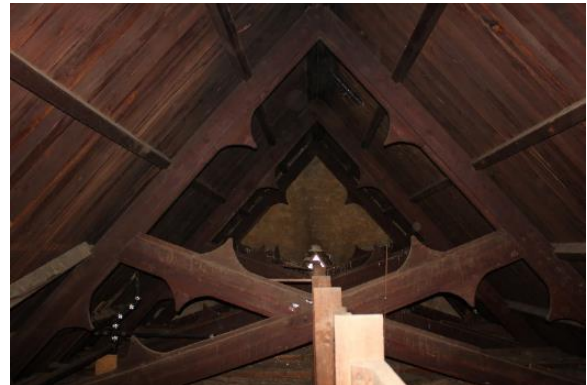
Exposed wood roof framing consisting of rafters, purlins, and six scissor trusses with decorative, carved wood pieces at the faces of the chords and scissor beams. There are four purlins at either side of the roof ridge. Evidence of fire damage is present on the purlins and roof sheathing at the east end of this wing.

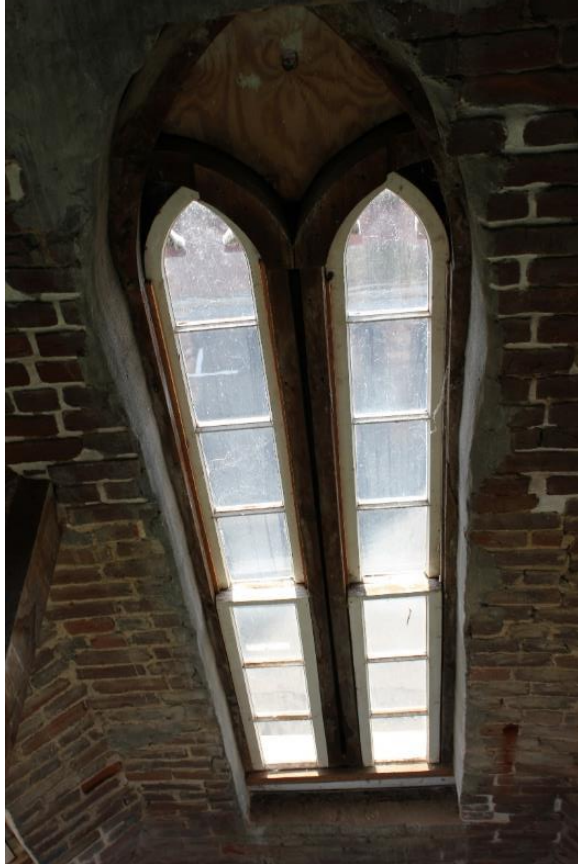
The walls are comprised of exposed brick. Multiple areas of the walls, particularly around the windows, have been inappropriately patched and re-pointed with Portland Cement based mortar. Localized areas of missing mortar are found throughout the wall of the bell tower. Moisture infiltration is degrading the condition of the bricks as large amounts of brick dust were found throughout the bell tower.

Figure 3.203, Historic Courthouse, Bell Tower, Room 302, view of a third-story window. Note the Portland Cement based mortar patching.

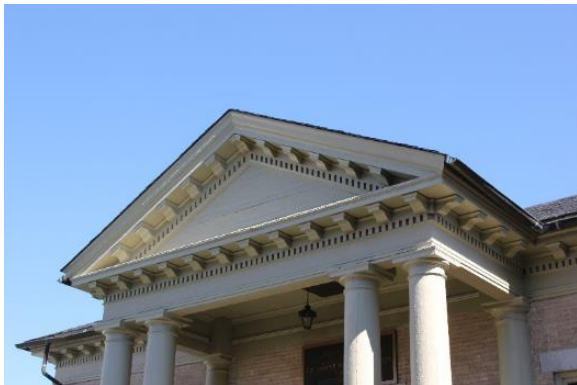
The hipped roof is clad in slate, with a front-gabled full-height porch. The roof is in fairly good condition, with few broken slates noted. The gutters are copper. The southern gutter of the porch roof is separating from the

roof, allowing water to run down the corner between the porch and main body of the building.

Figure 3.213, Wallace Library, West elevation, detail of porch roof.

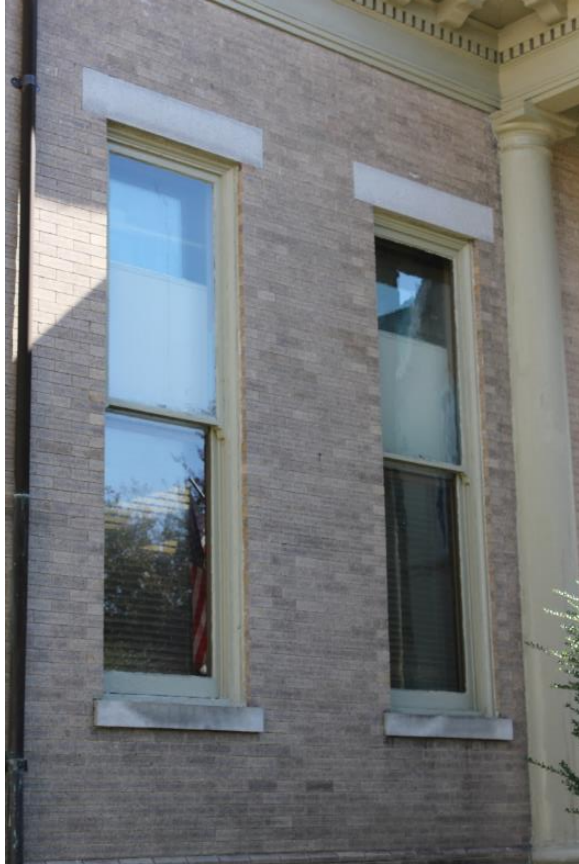
Figure 3.215, Wallace Library, West elevation, detail of windows. Note the second floor structure visible through the windows. Note the staining on the stone sills.

The west elevation features four wood double-height, one over one windows with stone sills and lintels. The sills show evidence of water stains. Mortar loss is common at the intersection of the window sills and the brick. The second floor structure is visible through the windows.

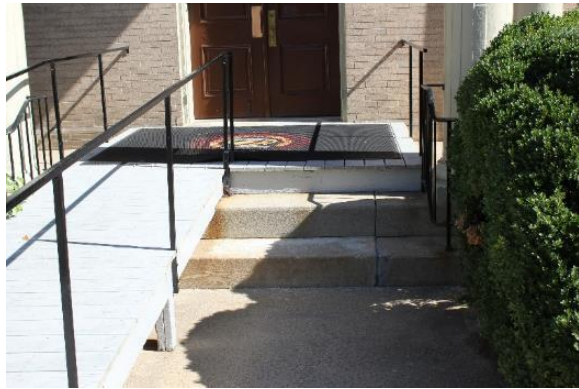
Figure 3.218, Wallace Library, West elevation, detail of ramp and platform overlay of historic porch.

At an unknown date a wooden platform and ramp were constructed, eliminating the need to step up from the porch to the first floor. The ramp and platform are painted and have black metal handrails. The handrails are rusting and

staining the concrete porch beneath the ramp and platform.

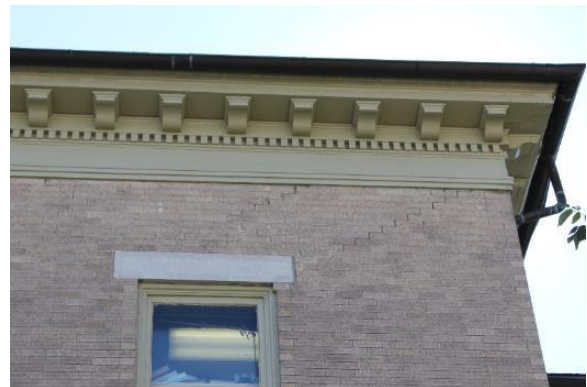
Figure 3.224, Wallace Library, North elevation, detail of cornice. Note the stepped cracks above the window.

The walls are composed of beige bricks laid in running bond. Mortar loss was generally found throughout the elevation. Stress cracks are visible throughout the elevation, particularly radiating from the corners of the windows.

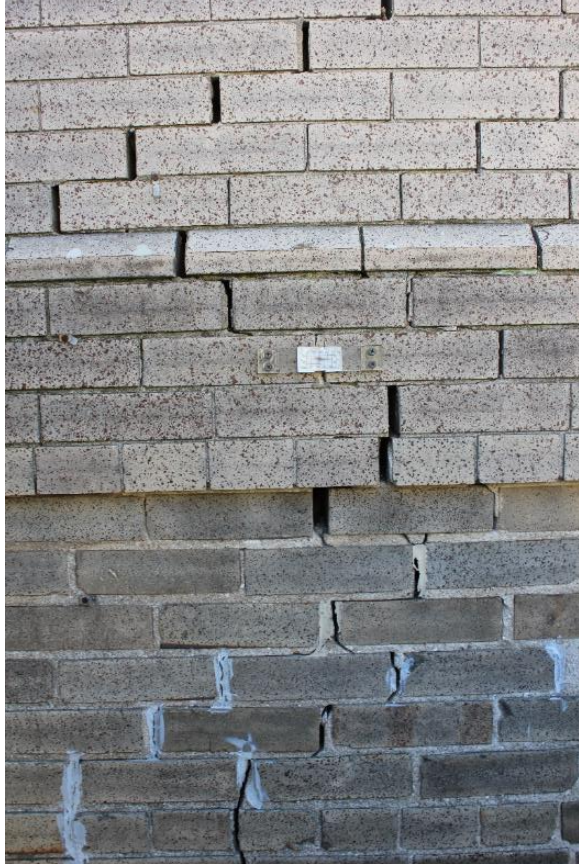
Figure 3.225, Wallace Library, North elevation, detail crack and shifting damage.

The foundation consists of beige bricks laid in running bond. A five-course water table with molded top course is located approximately sixteen inches above grade. The foundation is in poor condition. Shifting of the foundation is visible throughout the north elevation. Large cracks and some shear cracks are visible. In some areas, caulk or sealant has been applied to the cracks in order to stop water infiltration. The caulk or sealant is failing. As the walls were not reinforced or supported when the storage room in the basement was excavated, the wall appears to be buckling under pressure from the earth. Biological growth and splash-back are visible at the intersection of the wall and grade.

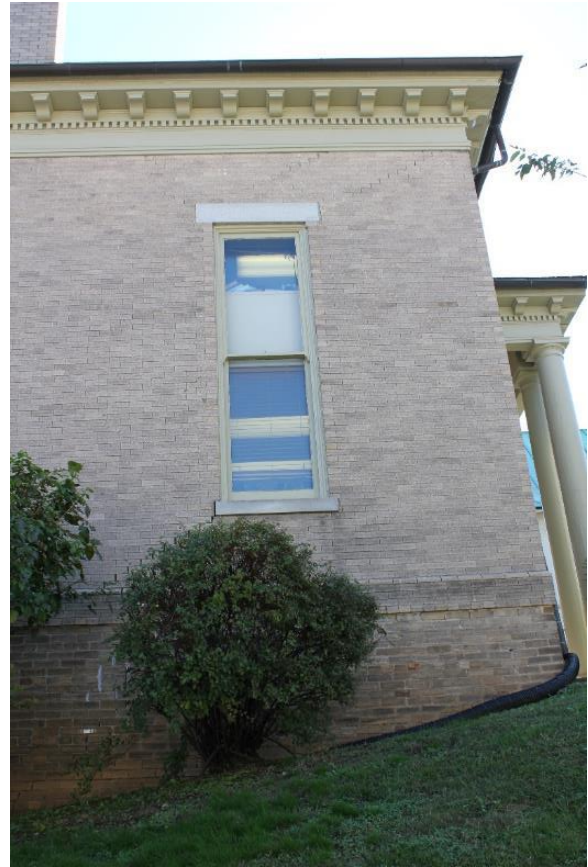
Figure 3.226, Wallace Library, North elevation, detail of window.

The north elevation features two wood double-height, one over one windows with stone sills and lintels. The sills show evidence of water stains. Mortar loss is common at the intersection of the window sills and the brick. A window air-conditioning unit is present in the eastern window. The second floor structure is visible through the windows.

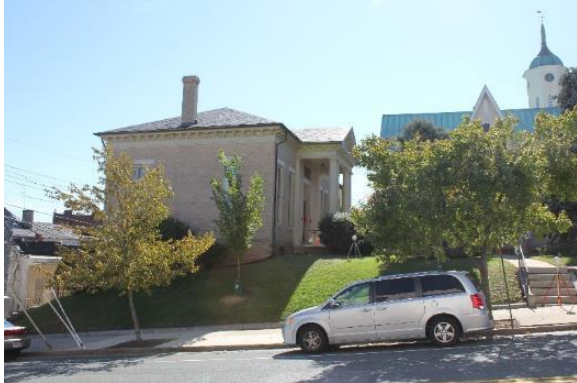
Figure 3.227, Wallace Library, North elevation, view of site.

The site slopes steeply away from the north elevation of the building down to a sidewalk which located at the edge of the sloping grassy yard. The north site is bound by George Street to the north. Small deciduous trees are planted within the slope. Several small bushes are planted in close proximity to the north elevation and are trapping moisture against the wall.

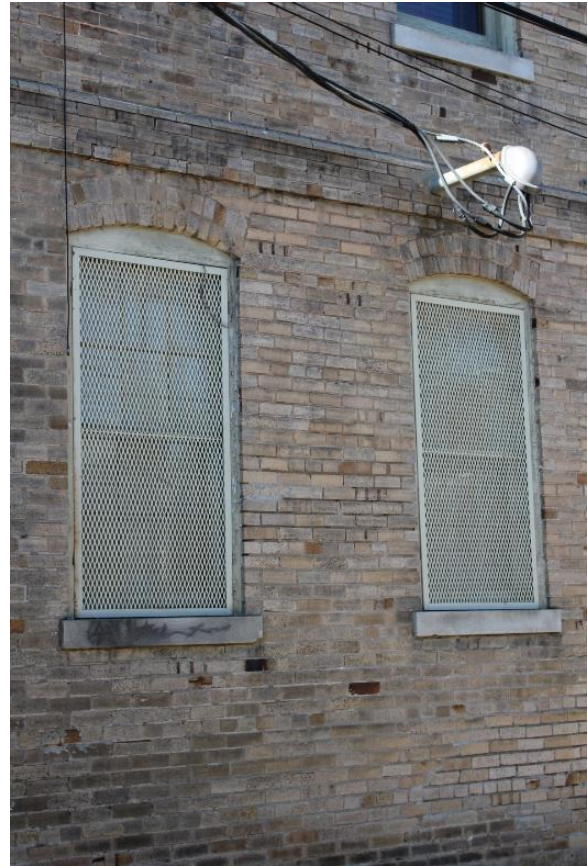
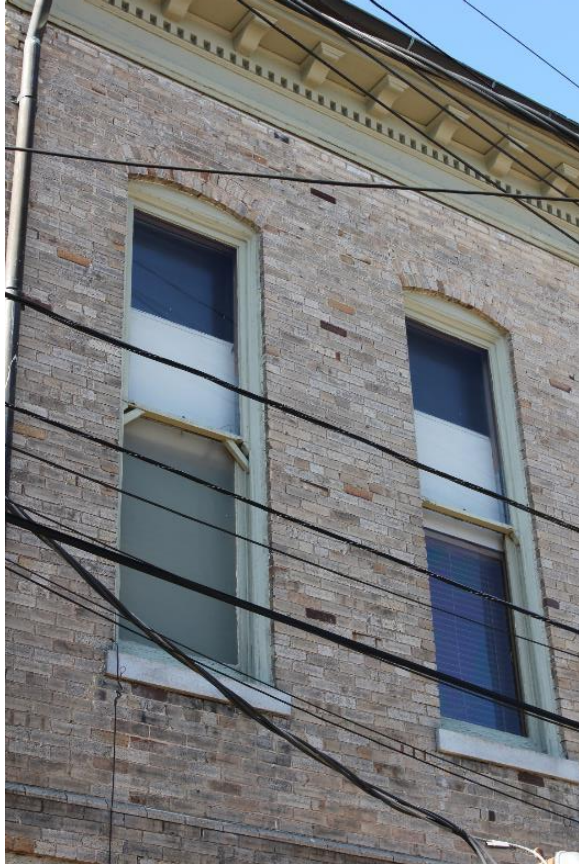
Figure 3.231, Wallace Library, East elevation, detail of basement windows.

Figure 3.232, Wallace Library, East elevation, detail of first and second floor windows.

The basement features five metal double-hung, six over six windows with brick segmental arch tops and stone sills. The windows exhibit signs of rust. Metal security grates are located on the basement windows.

The first floor features five wood double-height, one over one windows with stone sills and lintels. The sills show evidence of water stains. Mortar loss is common at the intersection of the window sills and the brick. A window air-conditioning unit is present in the eastern window. The second floor structure is visible through the windows.

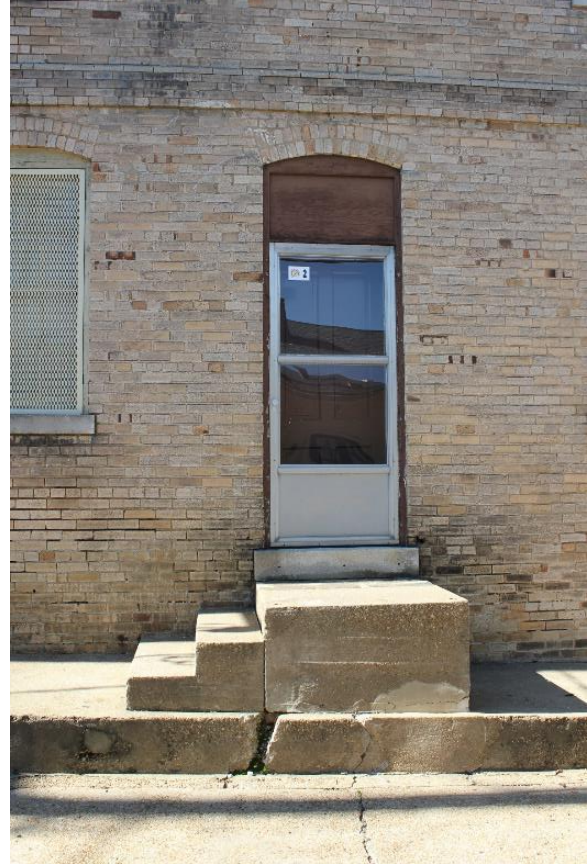
Figure 3.233, Wallace Library, East elevation, basement door and concrete stoop detail.

A concrete stoop is located in front of the door. Two concrete steps access the concrete sidewalk which runs parallel to the building. This porch is not designed to building code.

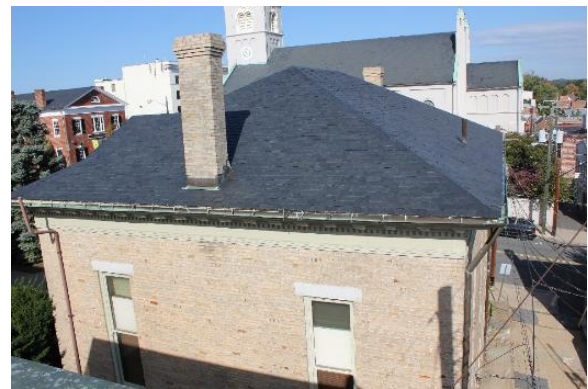
The hipped roof is clad in slate. The roof is in fairly good condition, with few broken slates noted. The gutters are copper. Some separation of the gutter from the roof is occurring in the southwest corner, allowing water to run down the face of the building.

Figure 3.239, Wallace Library, South elevation, detail of roof.

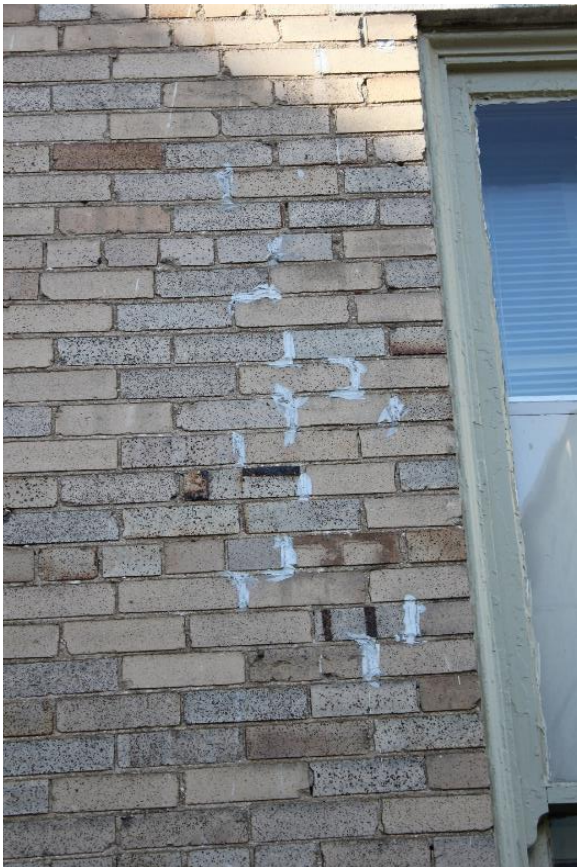
Figure 3.241, Wallace Library, South elevation, wall detail.

in fair condition. In some areas, caulk or sealant has been applied to areas where the mortar is missing. The caulk or sealant is failing.

The walls are composed of beige bricks laid in running bond. Mortar loss was generally found throughout the elevation.

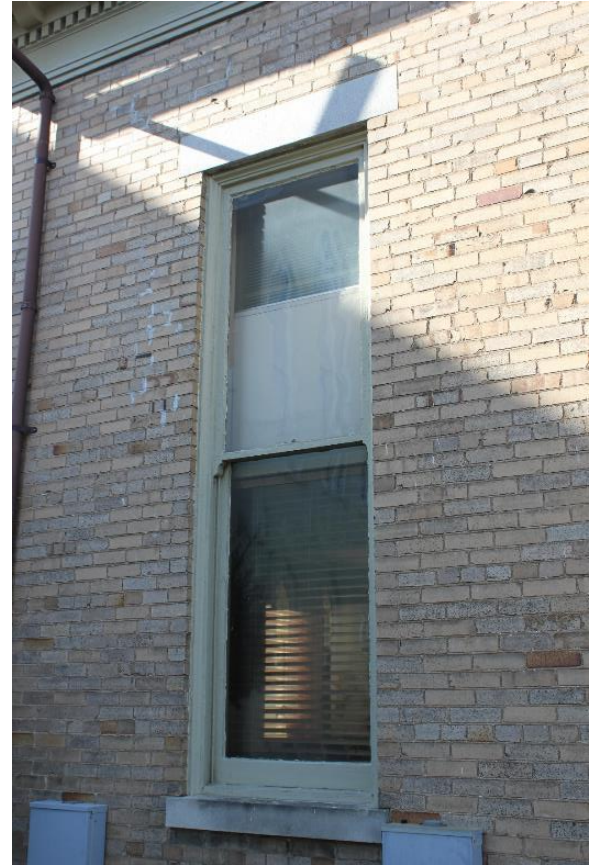
Figure 3.242, Wallace Library, South elevation, detail of window.

The south elevation features two wood double-height, one over one windows with stone sills and lintels. The sills show evidence of water stains. Mortar loss is common at the intersection of the window sills and the brick. The second floor structure is visible through the windows.

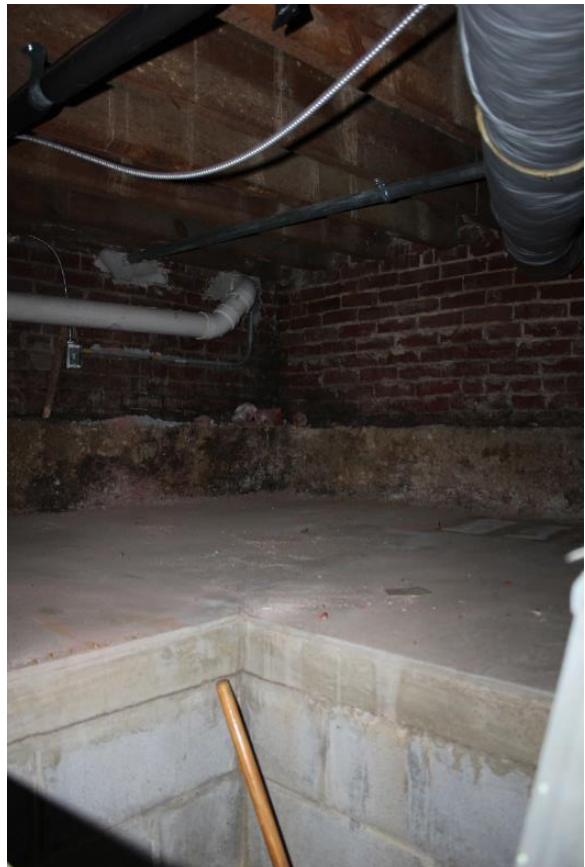
the north wall, which contains a step crack.
The mortar at all walls is typically uneven.
The haunch exhibits biological growth.

Figure 3.247, Old Wallace Library, Basement, Room 001, view of the concrete block ledge at the southwest corner of the room; note the biological growth where the ledge meets the wall.

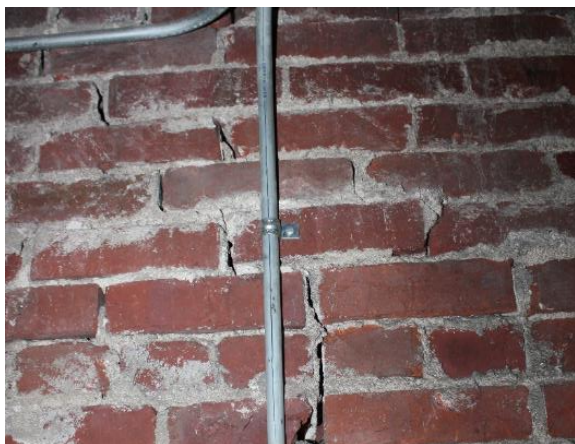
Figure 3.248, Old Wallace Library, Basement, Room 001, view of a step crack at the north wall.

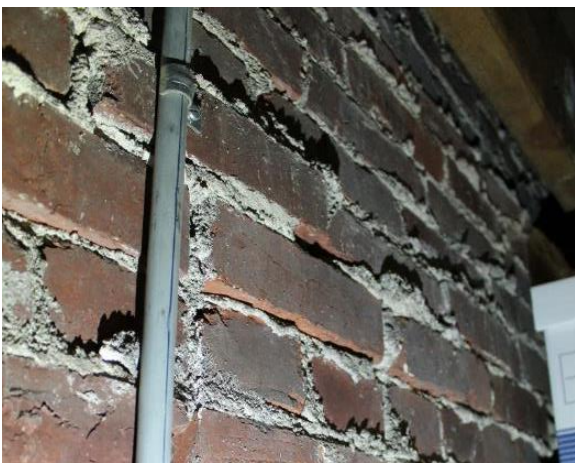
Figure 3.249, Old Wallace Library, Basement, Room 001, view of uneven mortar at the north wall.

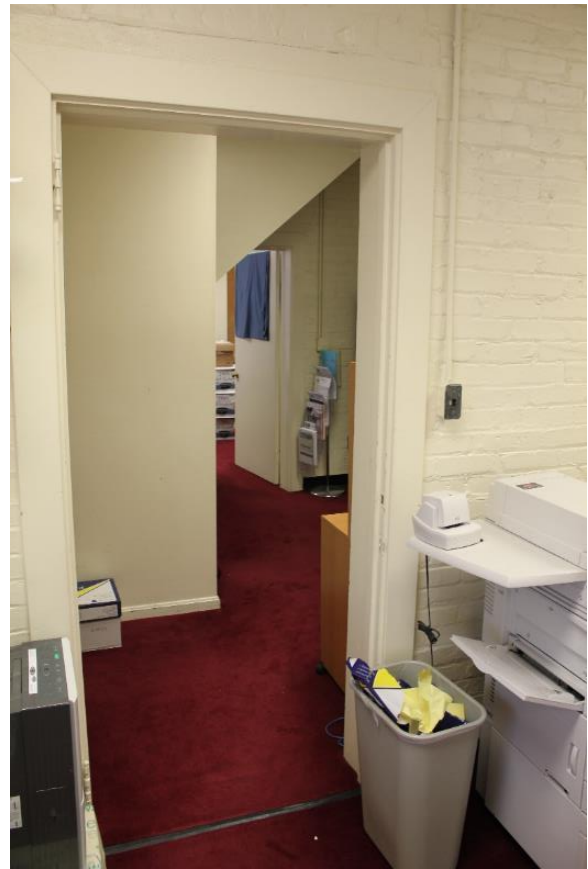
Figure 3.254, Old Wallace Library, Basement, Room 003, view of doorway at south wall; note remnants of hinges at trim, indicating that a door has been removed.

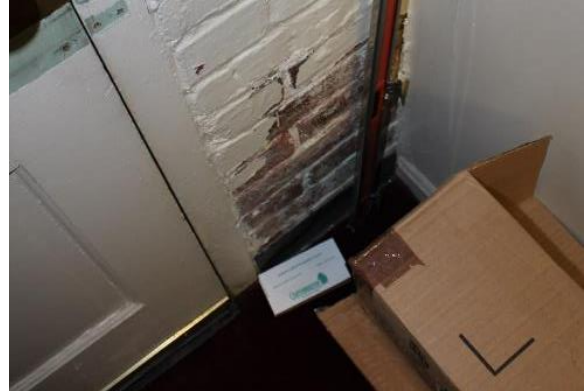
Figure 3.256, Old Wallace Library, Basement, Room 004, view of paint loss at east wall adjacent to the exterior door.

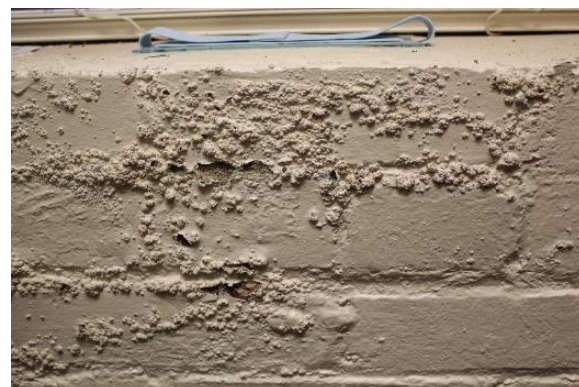
Figure 3.261, Old Wallace Library, Basement, Room 005, view of efflorescence at the painted brick wall underneath the south window.

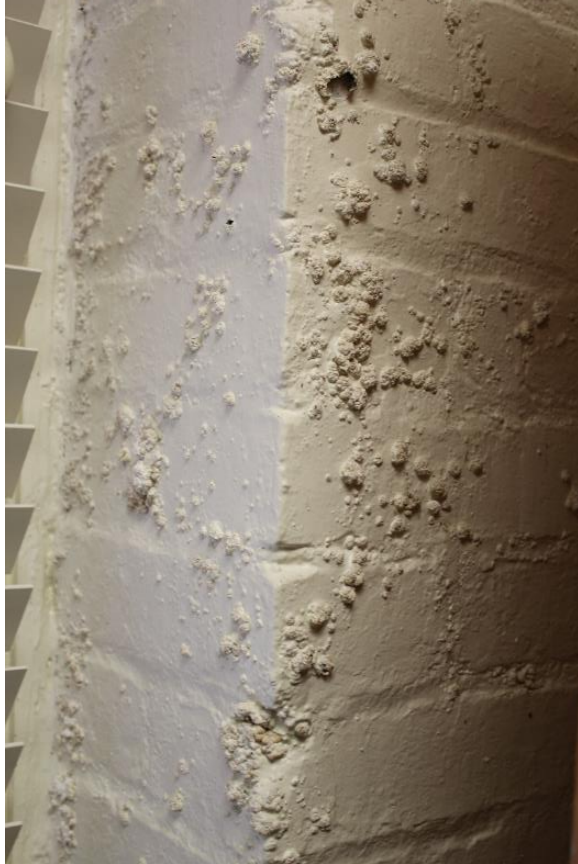
Figure 3.262, Old Wallace Library, Basement, Room 005, additional view of efflorescence adjacent to the south window.

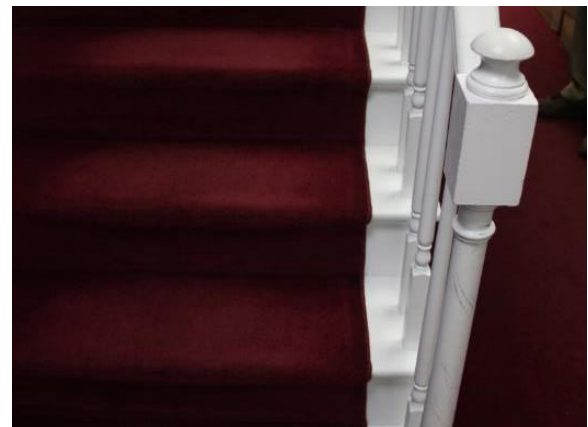
Figure 3.276, Old Wallace Library, First Floor, Room 104, detail view of turned newel post, which exhibits minor scuffing.

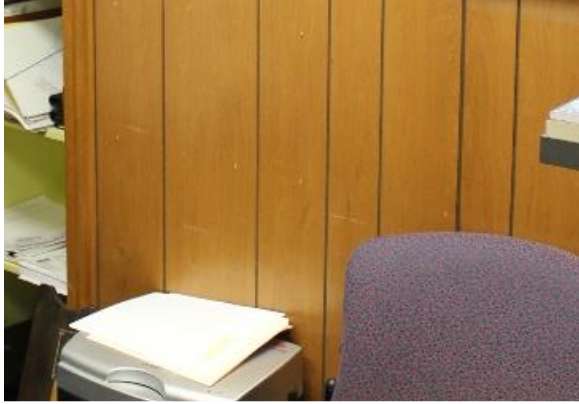
Figure 3.284, Old Wallace Library, First Floor, Room 107, detail view of minor scratches at faux wood paneling.

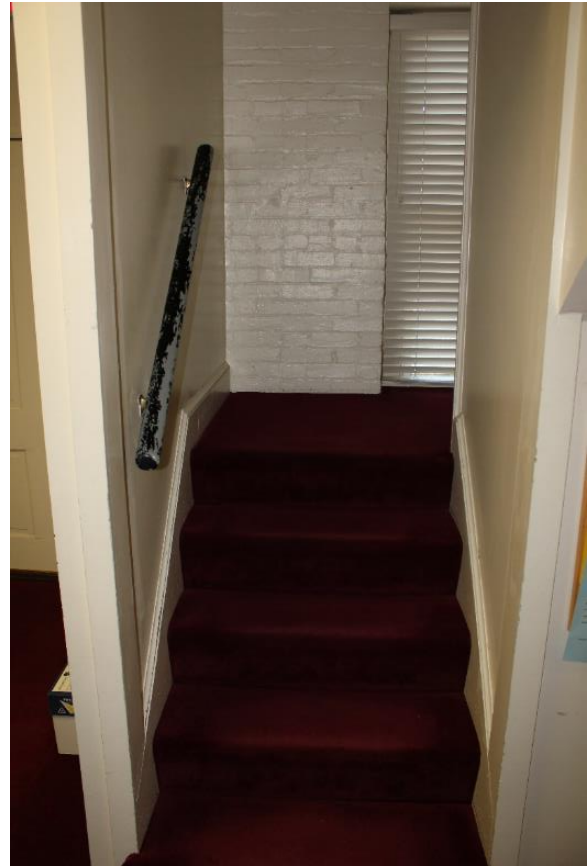
Figure 3.289, Old Wallace Library, First Floor, Room 109, view of lower flight of stairs. Note the heavy paint loss at the handrail.

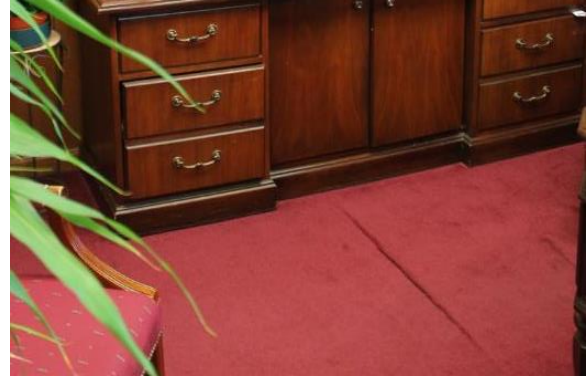
Figure 3.293, Old Wallace Library, First Floor, Room 110, detail view of wrinkles at carpet.

The floor is carpeted; the carpeting is loose and wrinkled in some areas.

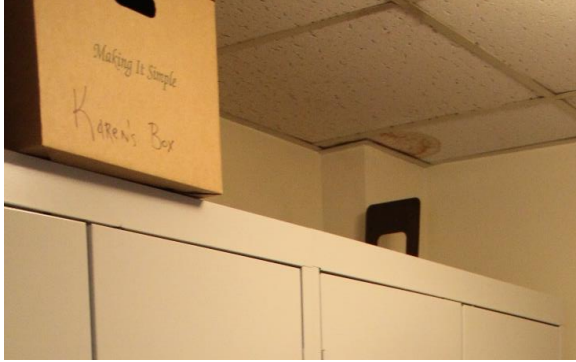
Figure 3.309, Old Wallace Library, Second Floor, Room 207, view of moisture staining at a ceiling tile.

The ceiling is covered in suspended acoustical tile. There is moisture staining at one of the tiles in the southeast corner of the room.

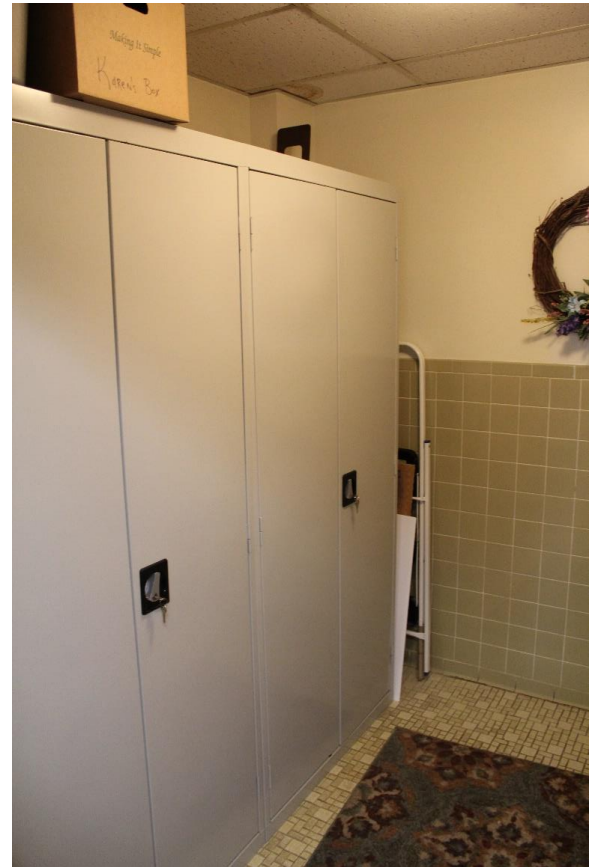
Figure 3.310, Old Wallace Library, Second Floor, Room 207, view looking southeast toward lockers. The lockers obscure a window at the east wall.

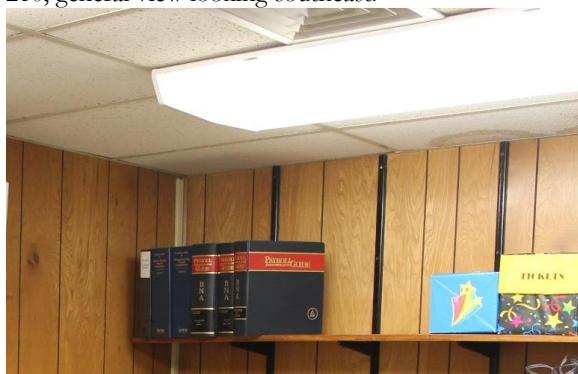
Figure 3.315, Old Wallace Library, Second Floor, Room 210, view of moisture staining at a ceiling tile.

The ceiling is covered in suspended acoustical tile. A ceiling tile adjacent to the south wall exhibits moisture staining.

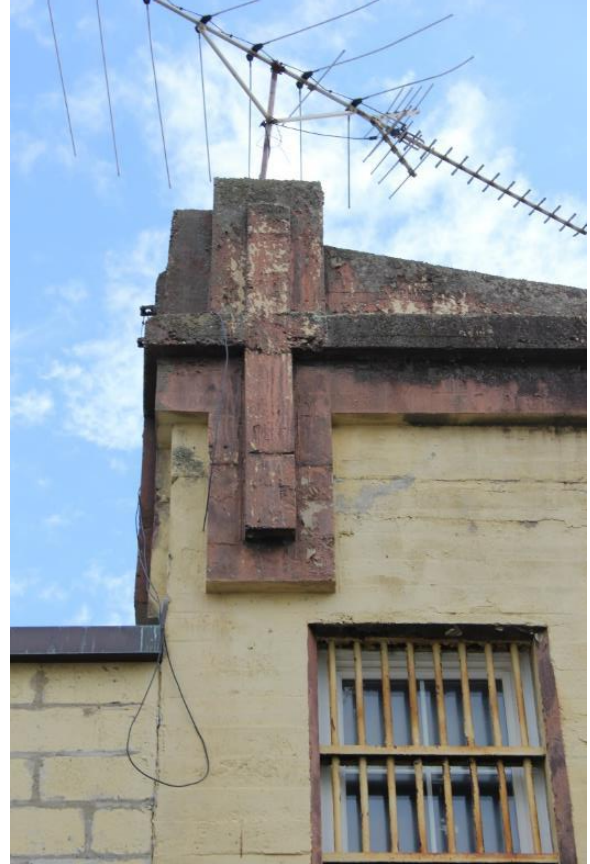
Figure 3.322, Old Jail, west elevation, view from the ground of parapets at higher roof. Note the transition in wall materials from concrete block (left) to poured-in-place concrete (right).

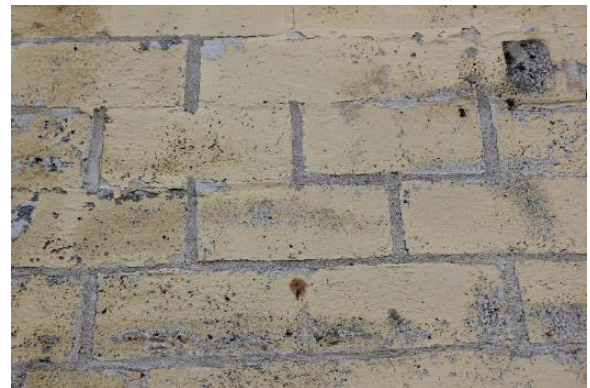
Figure 3.323, Old Jail, west elevation, detail view of painted concrete block wall. Note the areas of paint loss.

The wall is painted concrete block at the north (lower-roofed) section, painted, poured-in-place concrete at the south (higher-roofed) section, and partially-painted poured-in-place concrete at the south (one-story) wing. There is paint loss throughout, particularly at the second story of the north section. There are several vertical cracks near the foundation.

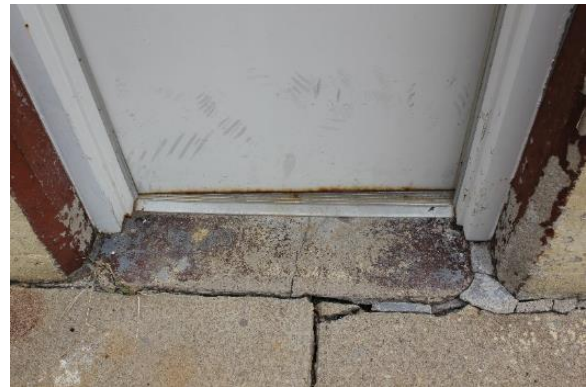
Figure 3.330, Old Jail, west elevation, view of cracked concrete at threshold of south door.

painted transom, and a flush concrete lintel. The center bay of the higher-roofed south end of the building contains a plain metal door with a brushed aluminum lever handle and a square window centered at its top half. The door has a narrow metal frame with a large, infilled, rectangular transom. The deep-set, painted door opening in the poured-in-place concrete wall has a beveled edge. The concrete threshold of this door is cracked.

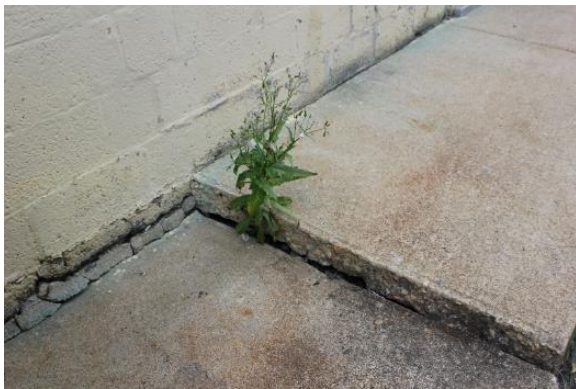
Figure 3.331, Old Jail, west elevation, view of uneven concrete walk.

An asphalt drive is located between the west elevation of the Old Jail and the east elevation of the courthouse, and there is a concrete walk adjoining the Old Jail's foundation. Some sections of the walk are uneven.

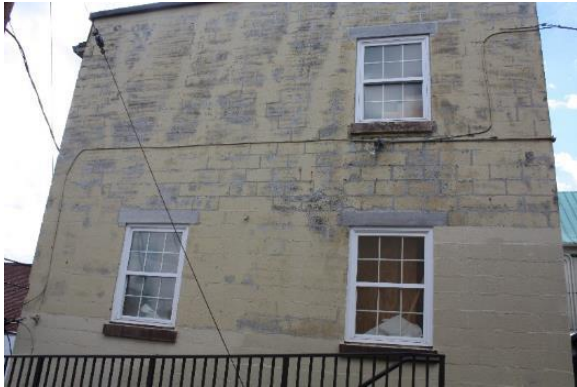
Figure 3.332, Old Jail, north elevation, general view looking south. Note the large areas of paint loss at the wall.

Wall:
The wall is painted concrete block and exhibits large areas of paint loss.

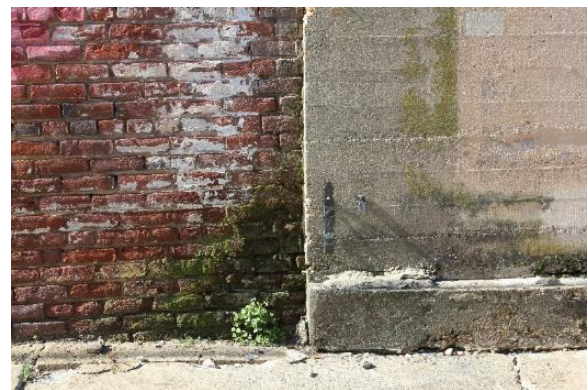
Figure 3.339, Old Jail, east elevation, view of basement at intersection of high- and low-roofed sections at the north end of the building. Note the large area of biological growth.

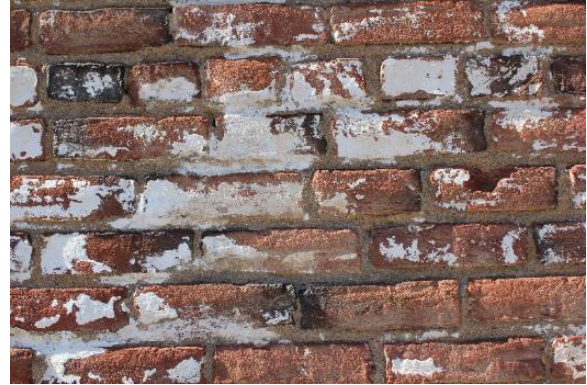
Figure 3.342, Old Jail, east elevation, detail view of brick at basement level of center section; note the efflorescence.

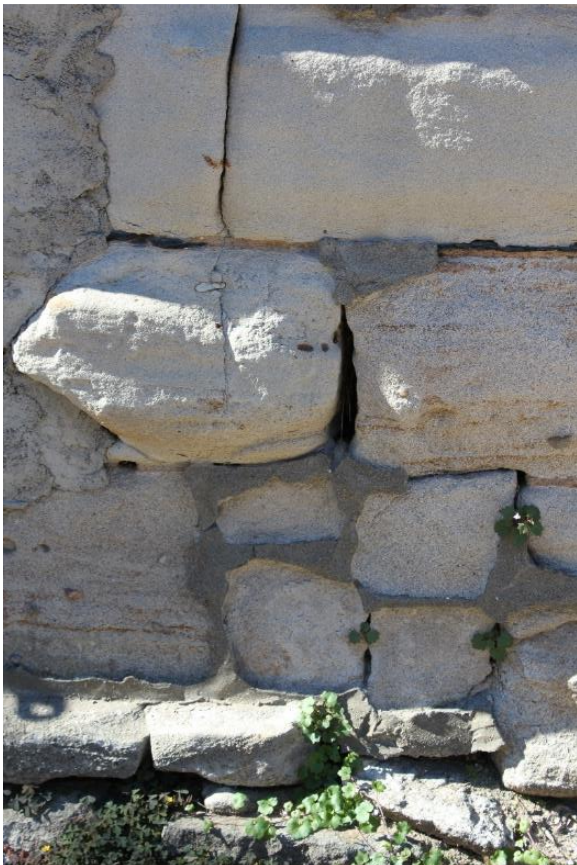
Figure 3.341, Old Jail, east elevation, detail view of rustic masonry at basement level; note the large areas of mortar loss.

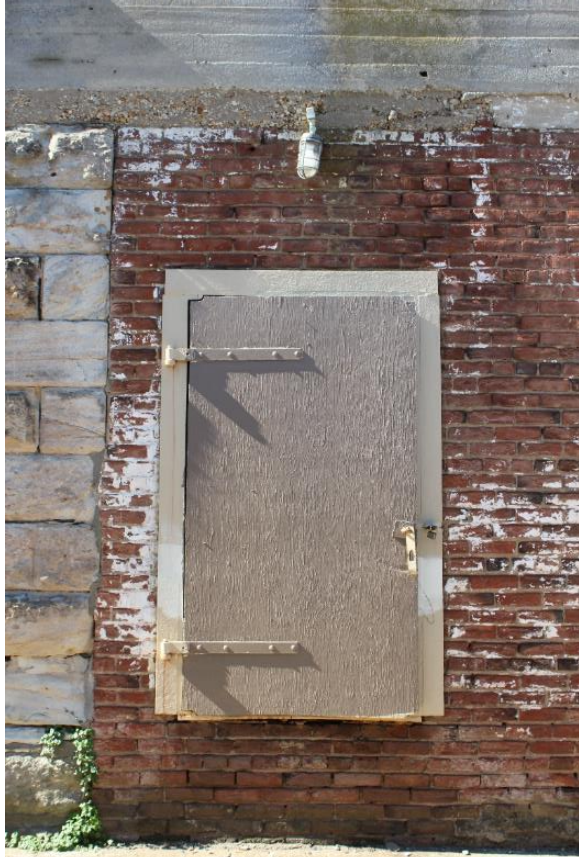
Figure 3.347, Old Jail, east elevation, view of north door at the high-roofed section. Note the lack of steps to access the door.

At the south end of the center exposed brick section at basement level there is a simple plywood door with large, painted metal strap hinges, a metal latch with removable key lock, and a flat, painted wood frame. At the north bay of the basement of the one-story wing, there is a plywood door set in a deep opening with a narrow wood frame, wood reveals, and a concrete threshold. This door has a large, vertical crack at the door frame. Both doors are set high on the wall with no steps to access them.

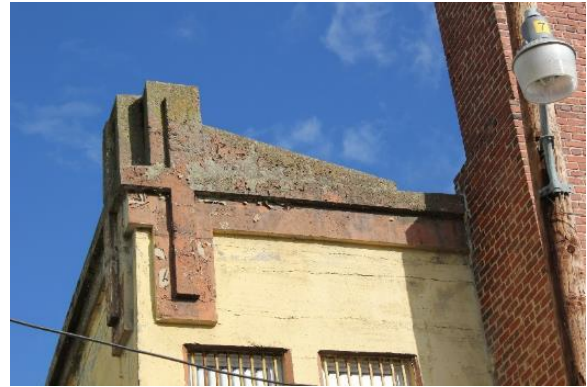
Figure 3.350, Old Jail, south elevation, view of parapet. Note the heavy paint loss and biological growth.

The wall is of poured-in-place concrete at both the main building and the one-story wing. The wing wall is partially painted. The west end of the parapet exhibits particularly heavy paint loss and biological growth. There is a large area of loss in the concrete block wall at the southeast corner of the one-story wing. Just below the cornice, the wall surface is spalling.

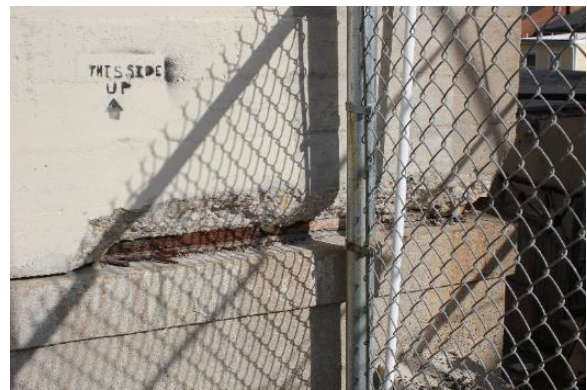
Figure 3.351, Old Jail, south elevation, view of an area of loss in the concrete wall at the southeast corner of the one-story wing.

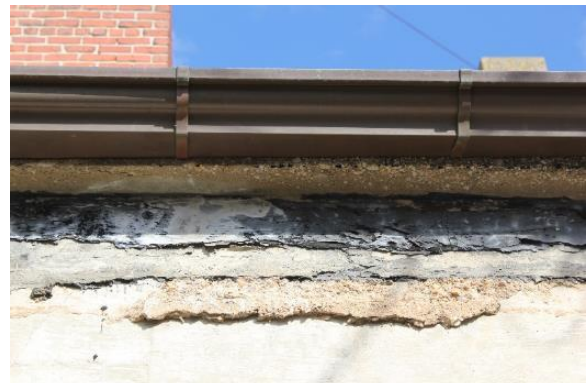
Figure 3.352, Old Jail, south elevation, view of spalling just below the cornice.

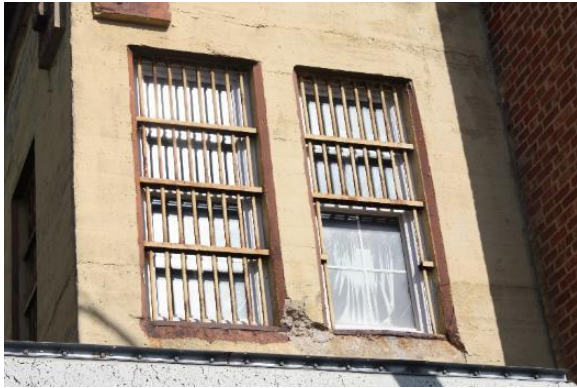
Figure 3.353, Old Jail, south elevation, view of second-story windows west of the chimney. Note the missing sills at both windows and removed bars at the east window. The concrete is spalling where the sills were formerly located.

Windows are four-over-four, hung, vinyl windows covered by bars. There is a pair of windows at the first story west of the chimney. Both have concrete sills. At the second story, there is a pair of windows to either side of the chimney. These are covered by bars; however, the bars are removed from the lower sashes of the windows closest to the chimney. All of the second-story windows are missing sills except for the far east window; the concrete wall is spalling where the sills are missing.

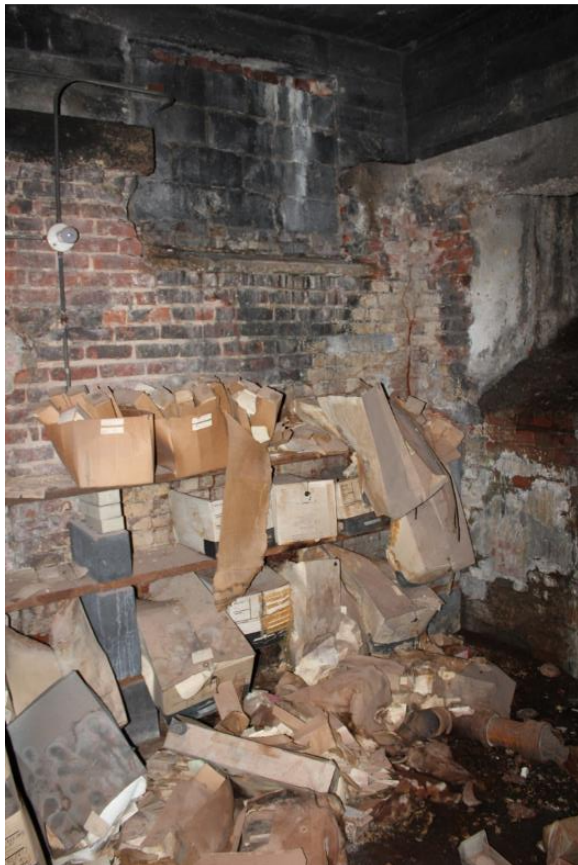
Figure 3.354, Old Jail, Basement, Room 001, general view looking southwest. Note the many moisture-deteriorated cardboard boxes and papers stored in the room and moisture staining under the infilled window.

The floor is of concrete. It is covered with dirt and other debris, mostly from the large number of moisture-deteriorated cardboard boxes and papers stored in the room.

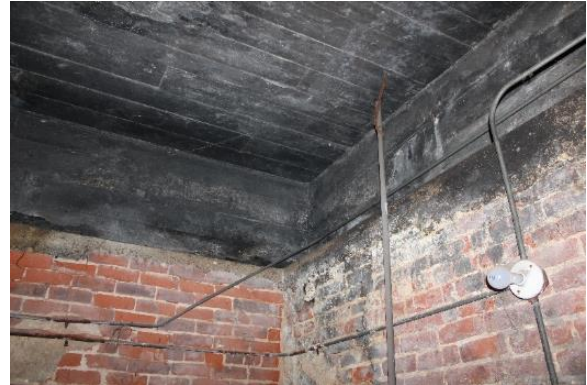
Figure 3.355, Old Jail, Basement, Room 001, view of efflorescence at the south brick wall.

The east, south, and west walls are brick at the lower two-thirds and poured-in-place concrete at the upper third. The north wall is concrete block at the lower two-thirds and poured-in-place concrete at the upper third. There is moisture staining at the brick below the south wall's window opening and the west wall's coal chute.

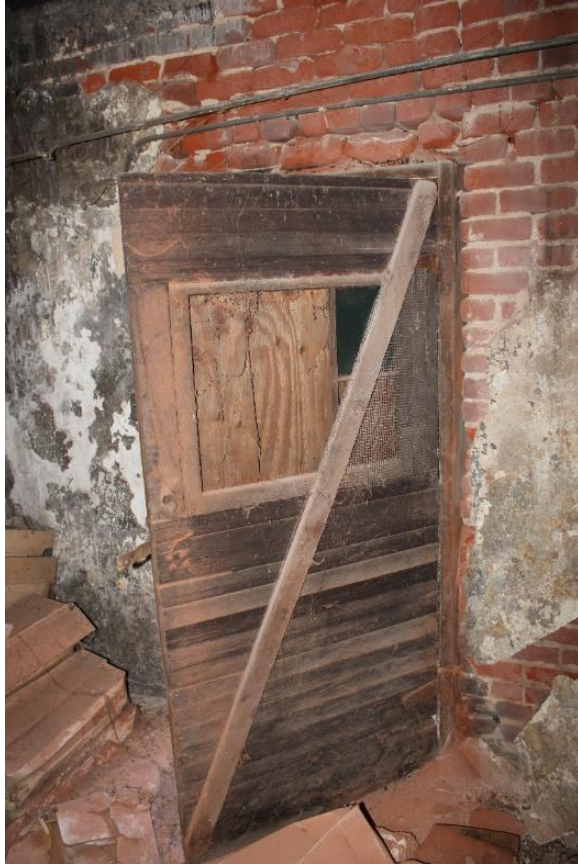
There is one door at the east wall. Its outer face is plywood and its inner face is unfinished board-and-batten with a rectangular window that is infilled with plywood. The door has an unfinished wood frame. It is heavily soiled with dirt and cobwebs. The two strap hinges and outer metal latch are rusted.

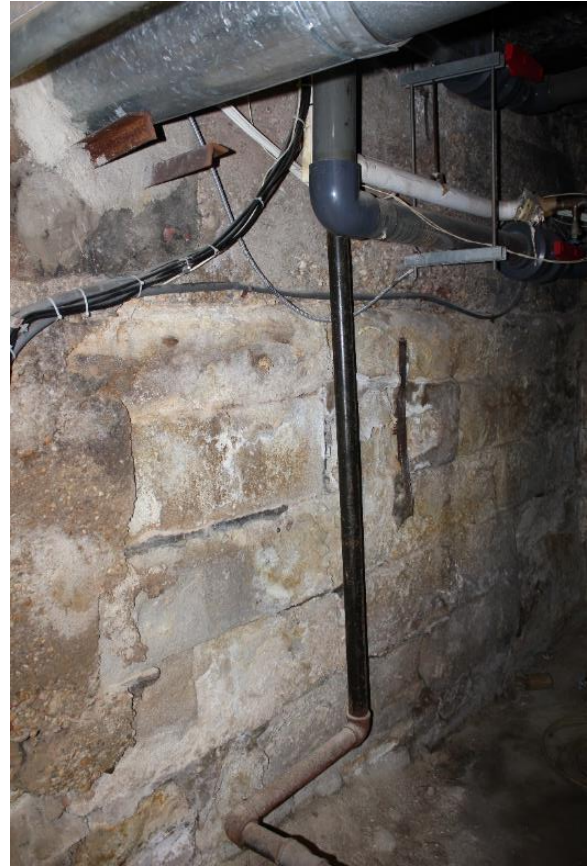
Figure 3.360, Old Jail, Basement, Room 002, view of efflorescence at stone walls.

The north wall is of brick and the remaining walls are of stone. An opening at the west wall is covered over at the outer wall with a mechanical grille and toward the center of the opening with metal bars, which are rusted. The stone walls exhibit areas of efflorescence and moisture staining.

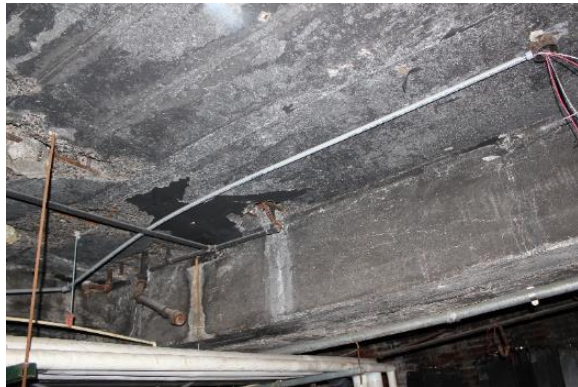
The ceiling is of poured-in-place concrete; it has some areas of loss and patching.

Figure 3.359, Old Jail, Basement, Room 002, view of poured-in-place concrete ceiling. Note the areas of loss and patching.

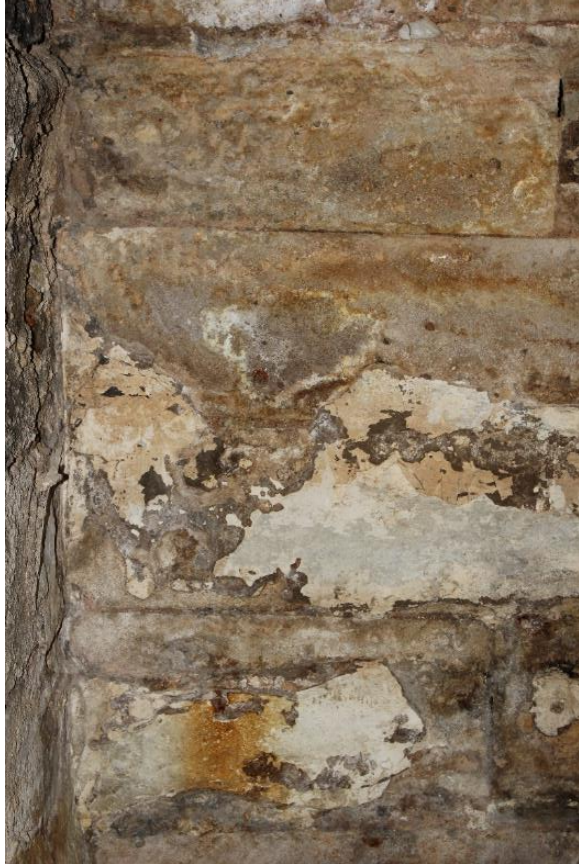
Figure 3.361, Old Jail, Basement, Room 002, detail view of efflorescence and moisture staining at stone walls.

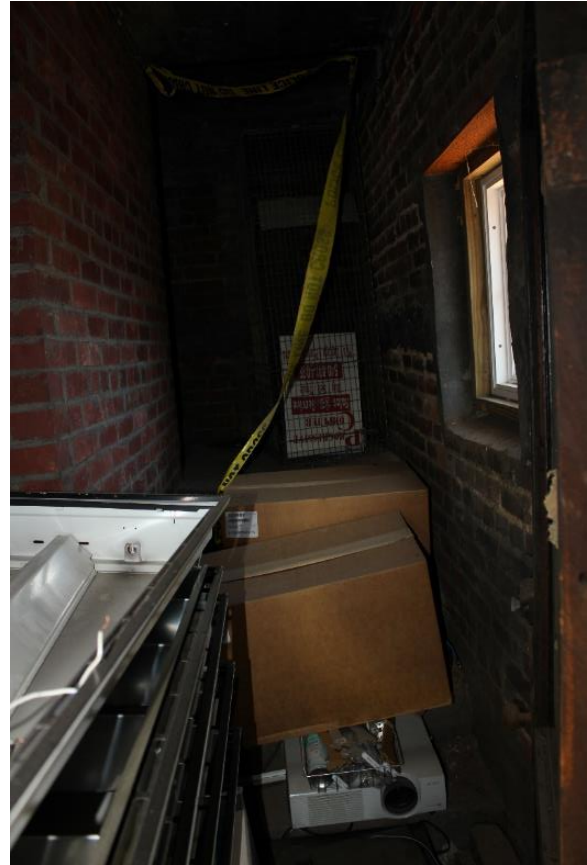
Figure 3.363, Old Jail, Basement, Room 003, general view looking north in the hall at the east wall. Note the stored material making it difficult to access all parts of the room.

There are many stored materials in the room, making it difficult to access all spaces.

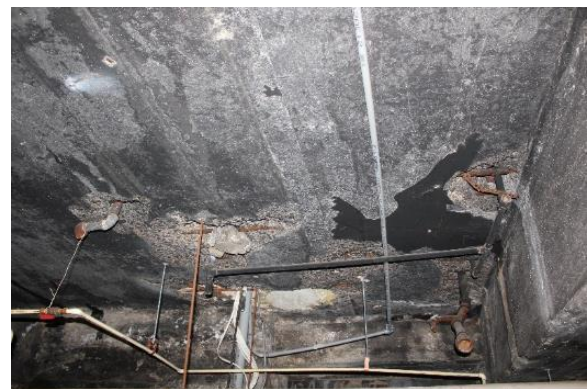
The ceiling is of poured-in-place concrete and exhibits areas of loss and patching; some of the pipes at the ceiling are exposed and rusted.

Figure 3.366, Old Jail, Basement, Room 003, view of the poured-in-place concrete ceiling. Note the areas of loss, patching, and exposed, rusted rebar and rusted pipes.

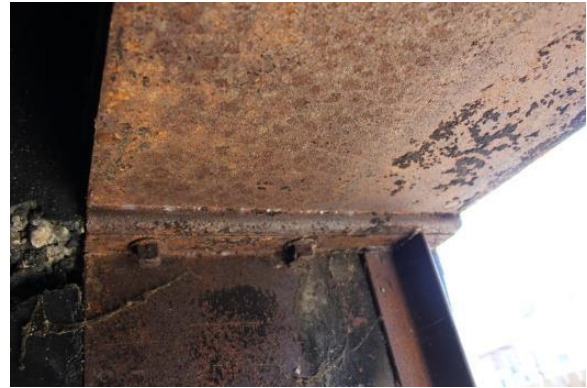
A wood door with center panel, metal butt hinges, and a plain wood frame is located toward the center of the hallway area east of the main room. The panel has an area of loss. A deep-set exterior door is located at the east wall; it is a simple plywood door with exterior latch closure and metal strap hinges; at the interior, the door has a metal frame, which is rusted.

Figure 3.369, Old Jail, Basement, Room 003, view of the rusted frame of the exterior door at the east wall.

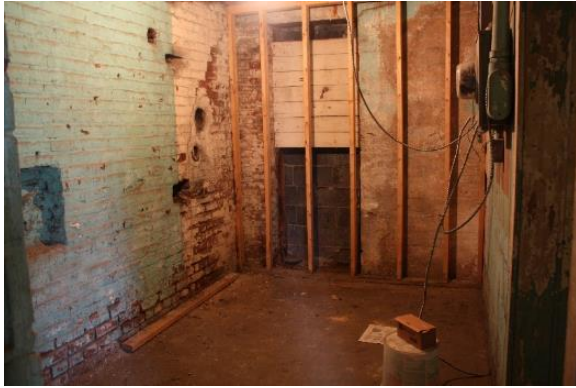
Figure 3.370, Old Jail, Basement, Room 004, general view looking west. Note the holes at the south wall; the former door opening infilled with concrete block; the large areas of paint loss; and the mix of building materials at the walls.
